# THE • INTERIOR • BUILDING ITS • ARCHITECTURE • AND • ITS • ART

PRESERVATION CASE STUDIES

David W. Look, AIA  
Carole L. Perrault

U.S. Department of the Interior  
National Park Service  
Preservation Assistance Division  
1986

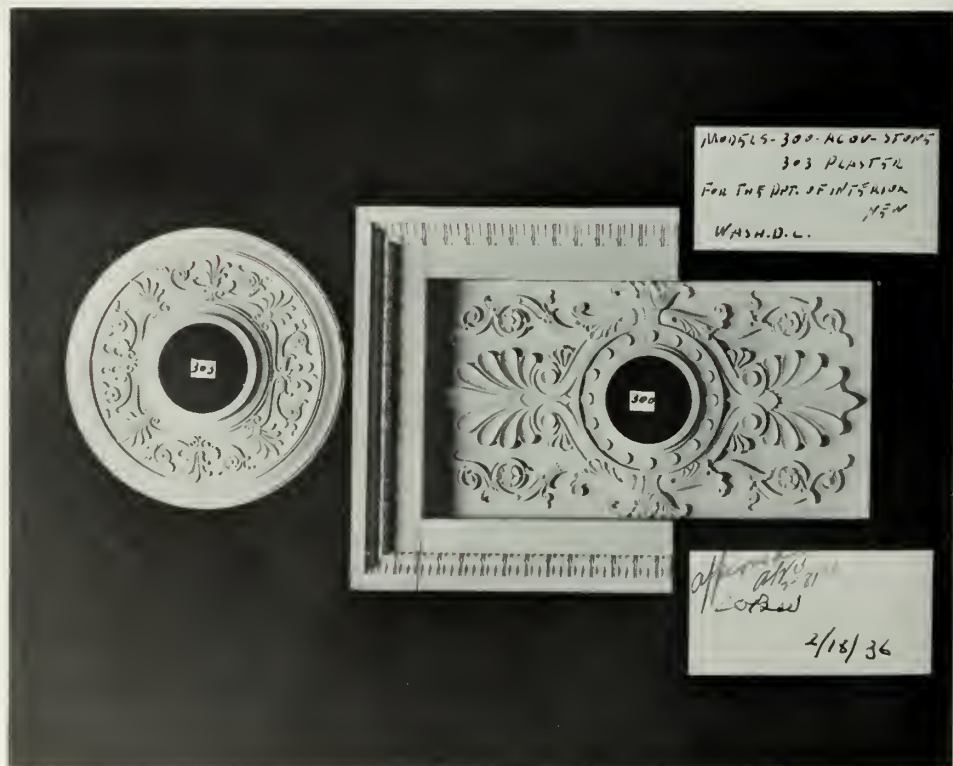
276

276. MODELS 300 AND 303. Model 300 with surrounding Doric molding is the design of the acoustic stone panels in the ceiling of the South Vestibule (see Fig. 35). The recessed panel consists of a circular rim inside a wider band with guttae flanked by embellished anthemion designs. Model 303 is the plaster ceiling medallion designed for the South Foyer and North Lobby Corridor (see

Fig. 52). The ornate anthemion band has a cyma recta border. The round opening in both models is for the light fixture Model 325 (see Fig. 282). Public Buildings Service, Photo No. 121-BS-102-11 in the National Archives, Washington, D.C.

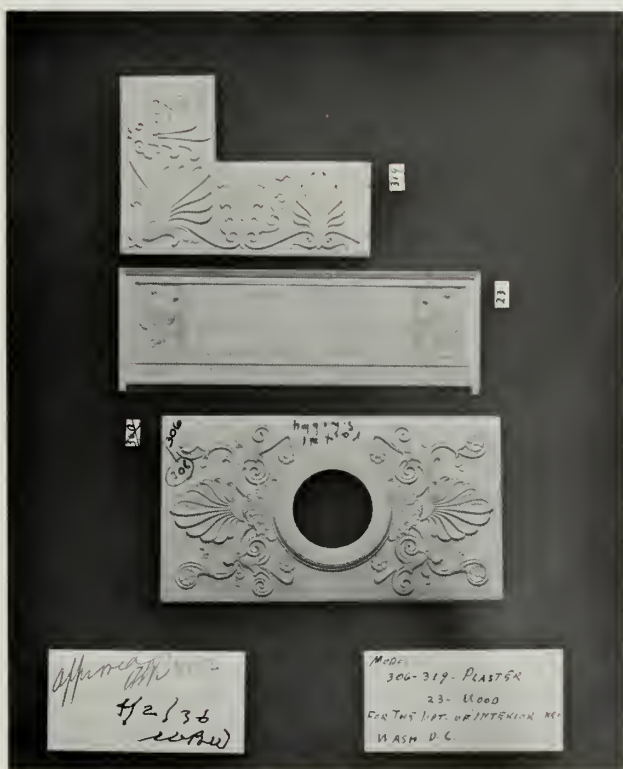
277

277. MODELS 319, 23, AND 306. The ceilings of the Auditorium (Conference Hall, Figs. 146 and 275); the Secretary's Office, Room 6156 (see Fig. 109); and the Secretary's Conference Room, Room 5160 (see Fig. 128), have hard plaster borders of similar anthemion design in bas-relief. Model 319 is the anthemion band that decorates the Secretary's Conference Room (see Fig. 128). Model 23 is the carved wood panel above the entrance of the Secretary's Suite, 6000 (see Fig. 100). The center panel which has the title of the office carved in the oak is flanked by two eagles in profile facing the center panel with wings raised. The plaster model for the ceiling of the North Vestibule (Fig. 46) is Model 306. Similar to the design for the South Vestibule, Model 306 has anthemion designs flanking a center round light fixture, Model 325 (see Fig. 282). The major difference is in the materials: the ceiling of the South Vestibule is acoustic stone and the ceiling of the North Vestibule is hard plaster. Public Buildings Service, Photo No. 121-BS-102D-12 in the National Archives, Washington, D.C.

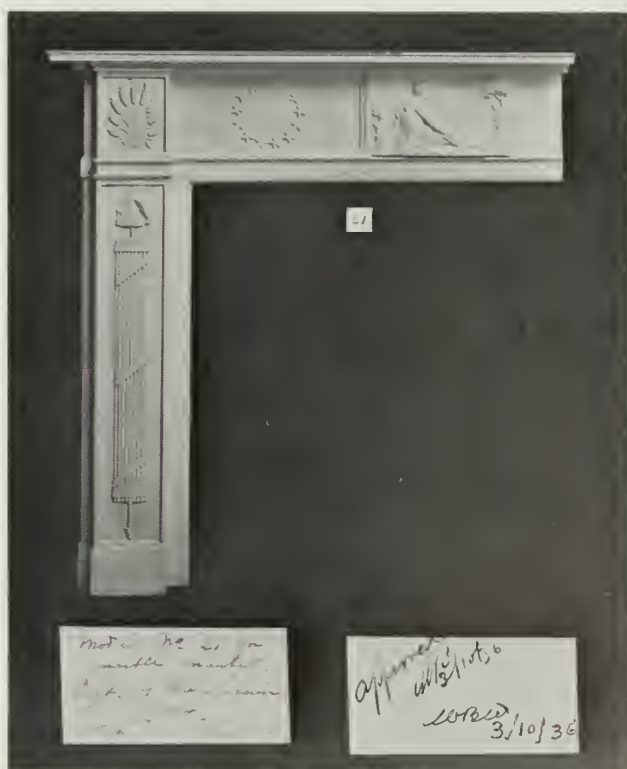
278

278. MODEL 21. One of the most impressive details in the Office of the Secretary, Room 6156, is the mantel. Model 21 is the plaster model of the Secretary's marble mantel, an exact copy of one of the mantels in the Old Senate Chambers in the United States Capitol. Benjamin Henry Latrobe, the third Architect of the Capitol, ordered the mantels about 1812 from Traquair Marble Company of Philadelphia. Giovanni Andrei of Latrobe's office made the drawings. When the British burned the Capitol in 1814, the mantels were boxed, ready for shipment to Washington. For over three years they remained in their

crates. In the rebuilding of the Capitol, Latrobe wrote the company about the original order and learned that the mantels were available and ready to be installed in the Senate Chambers. Latrobe resigned in 1817 and the mantels were installed by Charles Bulfinch in 1819. Waddy B. Wood was a close friend of David Lynn, Architect of the Capitol from 1923 to 1954. After the New Senate Chambers were constructed in 1859, the Old Senate Chambers were used by the Supreme Court. In 1935 the Supreme Court moved to their new building. Perhaps Mr. Lynn suggested that Mr. Wood have one of the mantels copied for the new Interior Building since the Old Senate Chambers had just been vacated and these mantels had been previously copied for other locations within the Capitol. A. Bussard and Company measured and made a plaster copy of one of the mantels in 1936. The Vermont Marble Company of Proctor, Vermont, fabricated the mantel of three marbles for the Office of the Secretary (see Fig. 114). The face of the mantel is Vermont White Statuary Marble with polished finish; the mantel shelf, sides, and firebox surround are Vermont Livido Marble with polished finish; and the hearth is Virginia Royal Black Marble with both honed finish and polished finish. The facing of the mantel is delicately carved with a legendary scene, flanked by two rings of 13 five-pointed stars around radiating rays. The legendary scene depicts a bearded man sitting on the ground between a stump and a tree and holding a bundle of rods. At the corners of the mantel are clusters of wheat and at the sides are bundles of rods topped by a phrygian cap, a symbol of liberty. The bundle of rods resembles a Roman fasces, a symbol of authority, but does not have an ax blade projecting from the bundle. Public Buildings Service, Photo No. 121-BS-102D-8 in the National Archives, Washington, D.C.

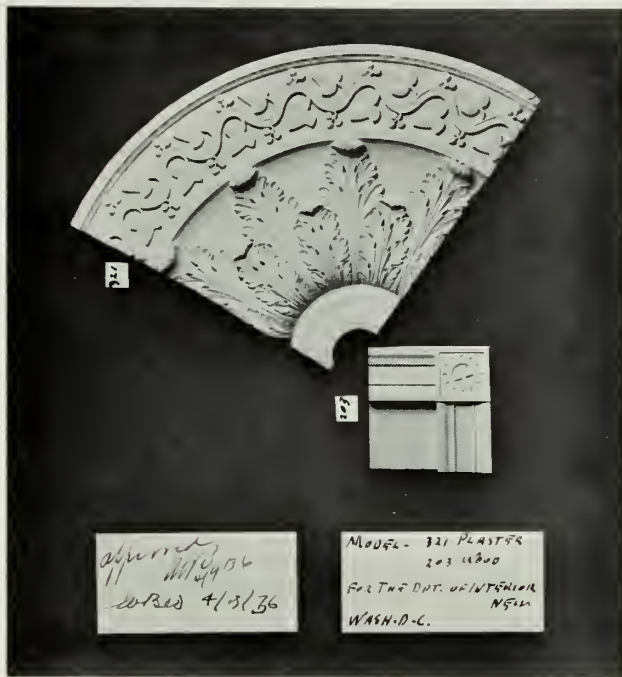
279

279. MODELS 321 AND 203. Model 321 is the approved plaster model of the ceiling medallion (see Fig. 115) for the Office of the Secretary, Room 6156. Since the design is symmetrical and repetitive, only a little over a quarter of the medallion was made. The medallion consists of alternating long and short acanthus leaves radiating from the center hub and a border of a serpentine ivy and berry design. The plaster medallions, as installed, are 6 feet in diameter. Model 203 (see Fig. 123) is the wood door surround for Room 6140 in the Secretary's Suite. The corner block has a large five-pointed star inscribed in a recessed circle and surrounded by a circle of 12 recessed, five-pointed stars. The door molding has a flat surface in the middle bordered on both sides by a bead, ogee, and a fillet. Public Buildings Service, Photo No. 121-BS-102D-13 in the National Archives, Washington, D.C.

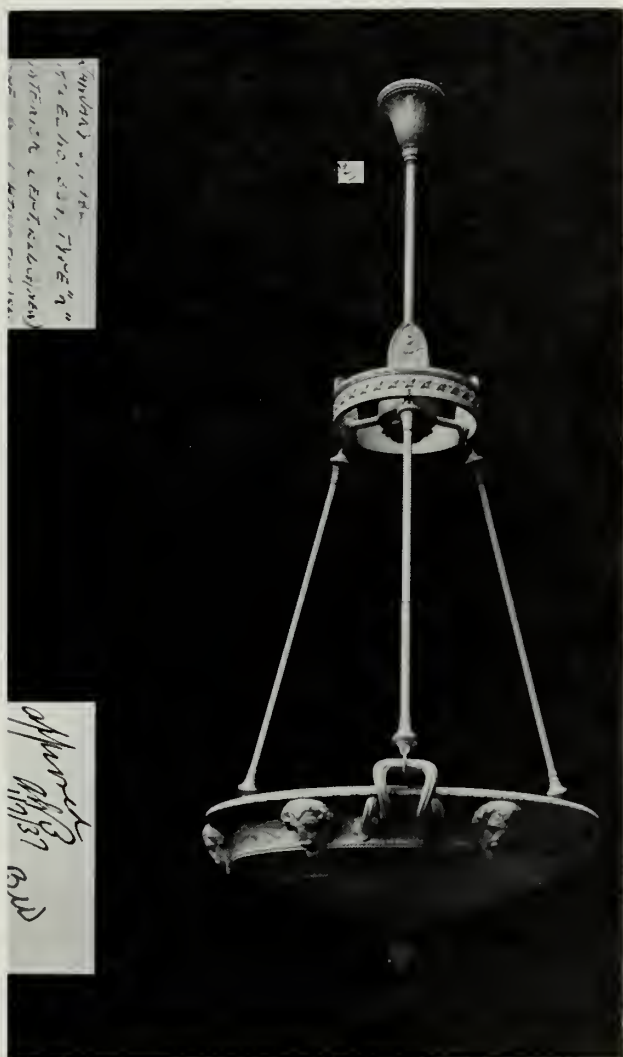
280

280. MODEL 339, TYPE R. The two light fixtures (see Fig. 115) in the Office of the Secretary, Room 6156, were specially designed for the Interior Building and are, therefore, unique. The model for the two-tone antique bronze chandelier, Model 339, Type R, was executed by the Washington Ornamental Co., Inc. Starting from the top and working down, the design consists of three stages: (1) the ceiling cap and rod supporting (2) the crown and three rods supporting (3) the bowl. The cap at the ceiling is decorated with overlapping laurel leaves radiating from the center and bordered by a bead. The single rod which supports the crown is reeded. The crown consists of a rim studded with five-pointed stars and surmounted with three antifixae. The motif on the pointed arch-shaped antifixae is an eagle with wings spread in front of radiating rays. Unlike the reeded rod that supports the crown, the three rods that support the bowl are hexagonal in section. The ends of the rods have rings through which pass the hoop fastened to the bowl. The rim of the bowl is concave with a Doric design on the upper lip and a bead around the bottom. Between the hoops is a stylized leaf design flanked by buffalo heads. The chandelier originally had an alabaster bowl with concentric rings and a bronze pineapple

ornament. The design was modified in 1964 (see Fig. 112). The bowl was replaced by a frosted glass bowl with a down light in the center. The new bowl and down light are supported by a hub with six radiating spokes (see Fig. 115). The hub has a beaded molding and the spokes are decorated with a stylized leaf design. Public Buildings Service, Photo No. 121-BS-102D-9 in the National Archives, Washington, D.C.

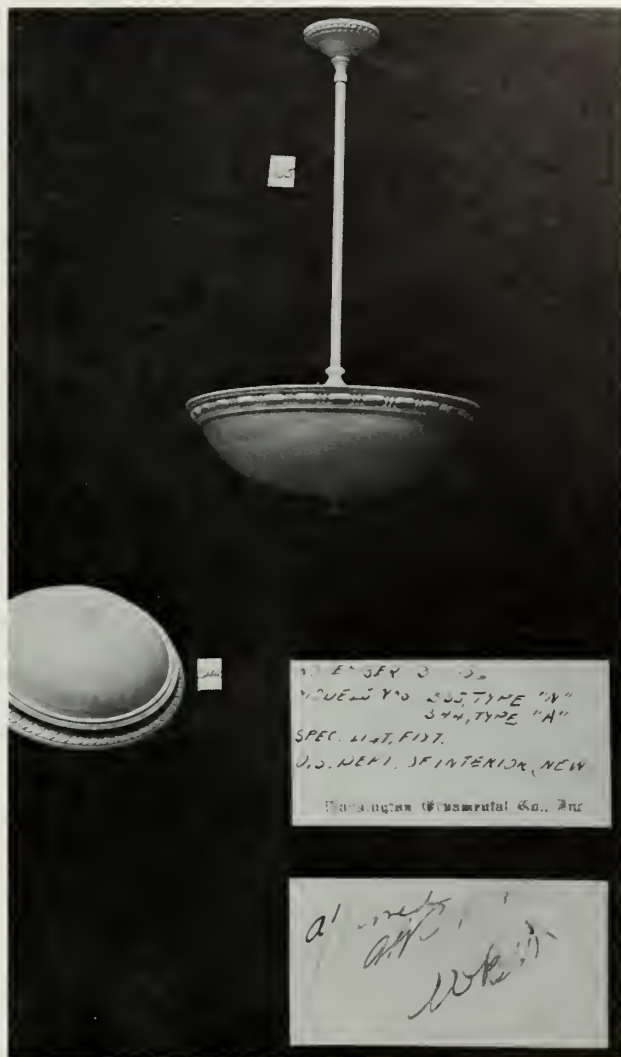
281

281. MODELS 335, TYPE N, AND 344, TYPE A. In 1967 most of the incandescent light fixtures in the offices and corridors were replaced by fluorescent lights. Very few of the original fixtures have survived *in situ*. The design of some of the lighting fixtures are known only by the photographs of the plaster models; their exact locations are unknown and can only be surmised by their size, type, and ornateness. On May 8, 1967, Mr. Harry Shooshan, Director of Resources Program Staff, requested that the original light fixtures in Rooms 7260 and 7261 be retained (see Figs. 86 and 87). Model 335, Type N, is the original model of the fixtures in these offices. The frosted glass bowl has a pineapple ornament at the center and a bronze rim with a bead-and-reel molding. The fixture is suspended from the ceiling by a reeded bronze rod and a cap with a beaded border. Examples of Model 344, Type A, have survived in the Museum on the first floor (see Fig. 165) and the two short side aisles flanking the Grand Stairs on the east side of the building in the basement. These incandescent fixtures are mounted flush against the ceiling. The frosted glass bowl has an etched border and the bronze rim has a border of overlapping laurel leaves. Public Buildings Service, Photo No. 121-BS-102D-15 in the National Archives, Washington, D.C.

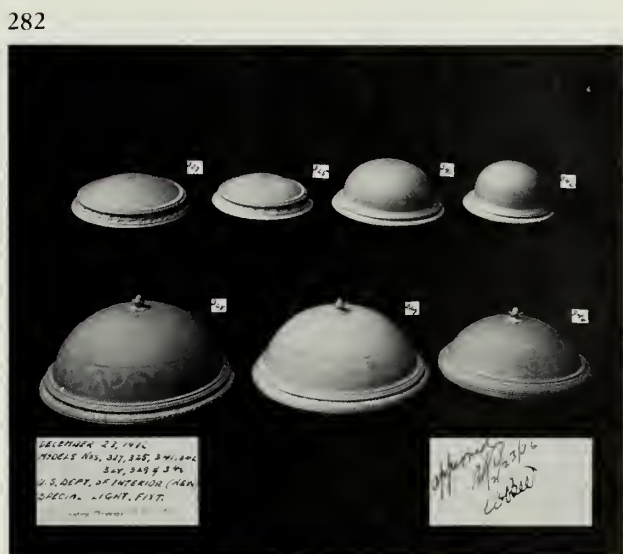
282

282. MODELS 327, 325, 341, 342, 328, 329, 346. These light fixtures were probably the most common fixtures in the Interior Building. All of these fixtures had frosted glass bowls and a bronze rim. Some had etched patterns on the bowl. Model 327 is the light fixture over the Grand Stairs (Stairs G) on the second floor (see Fig. 63). Model 325 is the ceiling fixture in the South and North Vestibules (see Figs. 35 and 46), the South Foyer (see Fig. 42), and the North Lobby Corridor (see Fig. 52). The only surviving example of Model 342 is in Room 6150, the passageway between Offices 6144 and 6154 (see Fig. 119). The exact location of Models 341, 328, 329, and 346 are unknown. The sizes of these fixtures strongly suggest that they were installed in the main corridors in the basement and the third through the seventh floors. Public Buildings Service, Photo No. 121-BS-102D-14 in the National Archives, Washington, D.C.

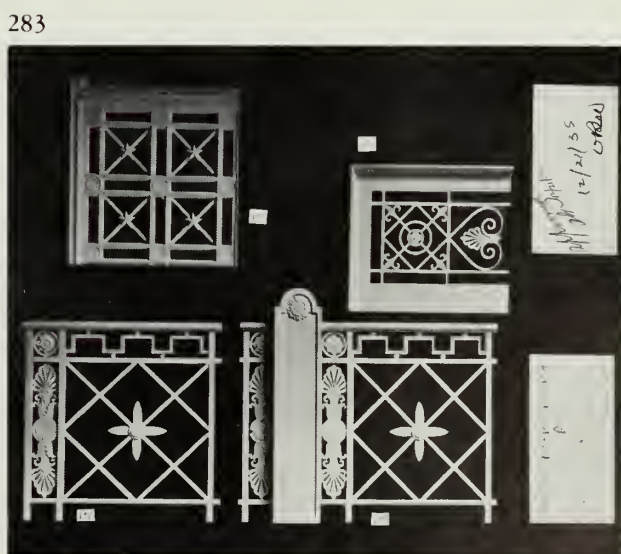
283

283. MODELS 100, 102, 103, AND 104. Model 100, the model for the bronze exterior doors at the south and north entrances (see Figs. 15 and 23), is a Roman grate design with a five-pointed star at the intersection of the X and a disc at the intersection of the double bars. Model 102, the plaster model for the bronze grille on the transom of the door to the South Loggia (see Fig. 18), consists of a center rectangular panel with an anthemion inside a heart-shaped design in mirror image. It is flanked by two square panels composed of concentric circles and diamond, crossed by an X, and embellished by a rosette at the center and buds at the corners. Model 103, the plaster model for the bronze railing of the South Loggia (see Fig. 17), consists of a superimposed diamond and Roman grate design with radiating leaves at the crossing of the X, with a Greek fret at the top. The ends of the railing have a panel with a center disc flanked by an anthemion motif and topped by an eight-petal rosette. Model 104, the plaster model of the railing of the window wells along the north elevation (see Fig. 25), is the same as Model 103 with the addition of a round top post embellished with an eight-petal rosette. Public Buildings Service, Photo No. 121-BS-102D-1 in the National Archives, Washington, D.C.

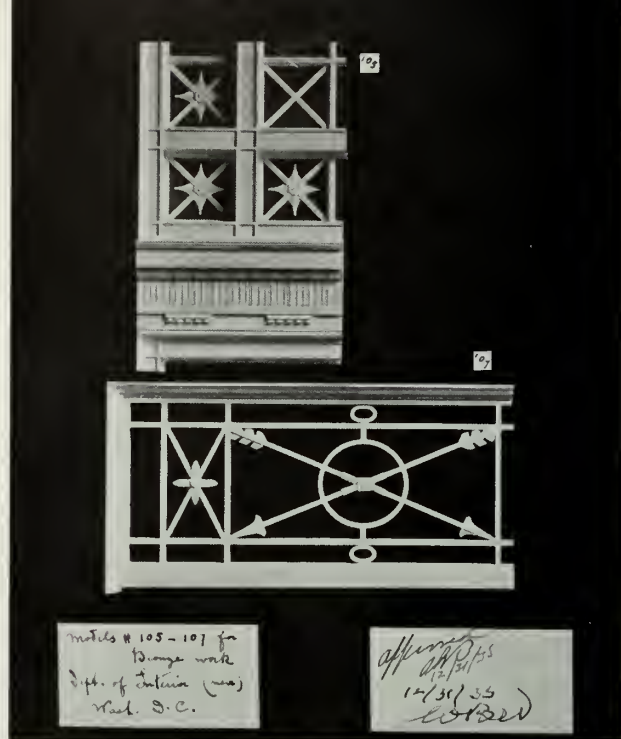
284

284. MODELS 105 AND 107. The transoms over the double doors at the entrances have bronze grilles (see Fig. 31). The design for the transoms over the double doors in the South Lobby is Model 105. It is a modified Roman grate design. The outside rows of designs have four-pointed stars at the crossing of the X's and are separated from the other designs by a wide double bar. Between the grille and the double doors is a Doric molding over six sets of regula and guttae. Model 107 is the transom over the bronze double doors in the South Foyer (see Fig. 42) and the North Lobby Corridor (see Fig. 50). The grille on the transom consists of a large horizontal rectangle flanked by two vertical rectangles. The side rectangles have a large X with a disc and radiating leaves at the crossing. The center rectangle is crossed by two arrows. The crossing of the arrows is bound together and inscribed in a circle. The three rectangles are suspended within the frame by short bars and by ovals (at the center). Public Buildings Service, Photo No. 121-BS-102D-2 in the National Archives, Washington, D.C.

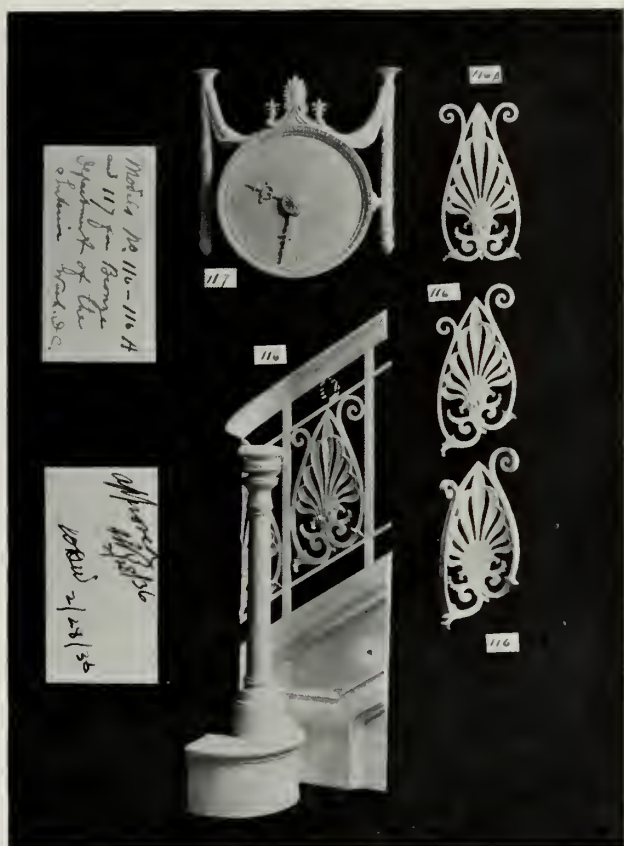
285

285. MODELS 117, 116, AND 116A. The most ornate clock in the Interior Building is the one designed for the Library Reading Room (see Figs. 148 and 155). Model 117, the plaster model for the two-tone bronze clock, consists of the clock suspended between bundles of staves and surmounted by anthemion antifixae and swag drapery. The white bronze face of the clock provides a subtle contrast with the yellow-bronze rosette in the center, the ornate hands, the Roman numerals, the bud-like motifs between the numbers, and the rim of egg-and-dart molding with bead-and-reel. The circular lines and the minute divisions are inscribed on the face. The model differs from the original drawing (see Fig. 148) in the design of the antifixae. Although the Grand Stairs (Stairs G), is the most elaborate in the Interior Building, it does not have the most ornate railings. Stairs M and N are embellished with classical motifs. Model 116, the plaster model for Stairs M in the Auditorium (Conference Hall), is a closed string stair. The design consists of a bronze column newel post with an anthemion band below a bead-and-reel for a capital, a curved wood handrail, bronze railing comprised of a series of large anthemion designs, wide bronze stringer, and stone steps with black Georgian marble treads and white Georgian marble risers. (In contrast, the fire stairs throughout the building have steel risers and railings, soapstone treads, terrazzo landings, and hard plaster walls and ceilings.) The anthemion designs going up and around the corner of Stairs M and N are slanted. Model 116A is the design for the level section of the railing on the upper landing. The original drawing for this stairs (see Fig. 133) and the model have an oval ring between the anthemion design and the handrail. The design was changed after the model was made. The photograph of the model has ink lines marking out the ring. The stairs as installed (see Fig. 145) have a parallelogram between the anthemion design and the handrail. Public Buildings Service, Photo No. 121-BS-102D-4 in the National Archives, Washington, D.C.

155. BRONZE CLOCK, READING ROOM, LIBRARY, WING 1100 WEST, FIRST FLOOR. This ornate bronze clock, Model No. 117, was especially designed for the Reading Room (see Figs. 148 and 285). Brooks Photographers, Bethesda, Maryland, 1976, HABS Collection.

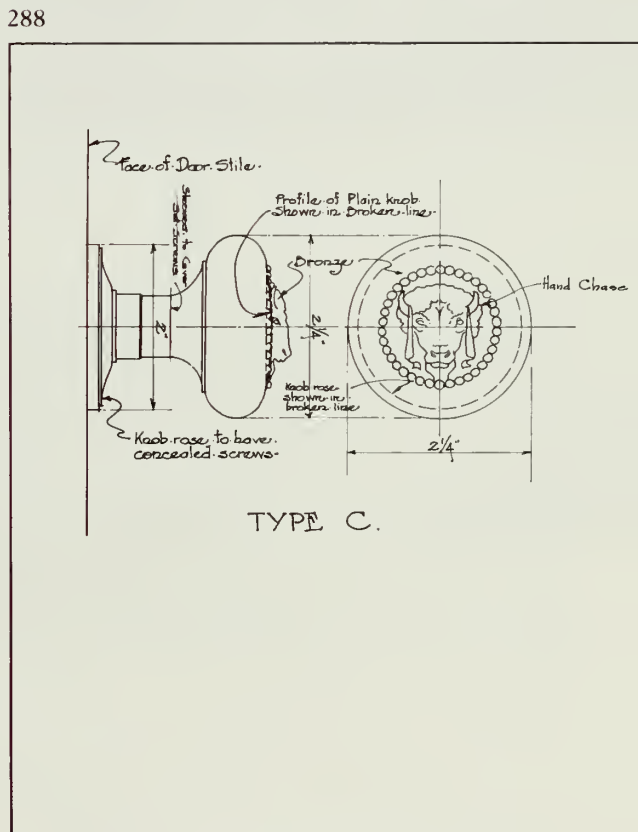
289

289. BUFFALO DOORKNOB. The buffalo doorknobs were designed for the Office of the Secretary (Suite 6000), the Under Secretary's Suite (5116), the First Assistant Secretary's Suite (6654), the Assistant Secretary's Suite (6616), the Secretary's Conference Room and Lobby (5160), the former Art Gallery (Wings 7100 East and West), and the Library (Wing 1100 West). The buffalo head on the doorknob, 2¼ inches in diameter, is a full frontal view of the head with Indian ornament hanging from the horns. A row of beads encircles the head. Above the doorknob the escutcheon consists of lightning bolts and a stylized eagle with spread wings and tail surmounted by a round disc and keyhole. Below the knob are stylized clouds. Total vertical dimension is 6½ inches. Brooks Photographers, Bethesda, Maryland, 1976, HABS Collection.

Room 6608: The walls of Room 6608 (Fig. 89) have painted birchwood, raised paneling both above and below the chair rail. The walls have a simple plaster cornice and a black marble base. Doors have a large recessed panel over a small lower panel. Between the upper and lower panels is a narrow horizontal panel. Door surrounds are fluted with corner blocks of concentric squares (Fig. 91). The double doors have specially designed door pulls (Fig. 291) and the single doors have buffalo doorknobs (Fig. 289). (For a description of the hardware, see Figs. 288-292).

These doors have an upper and lower louvered panel with a narrow, recessed panel between (Fig. 96). All rooms of this suite have a 6-inch black marble base. Most single doors have buffalo hardware (Fig. 289). Double doors have hardware (Fig. 291) identical to that of Suites 6000, 6116, and 6154. (For a description of the hardware, see Figs. 288-292.)

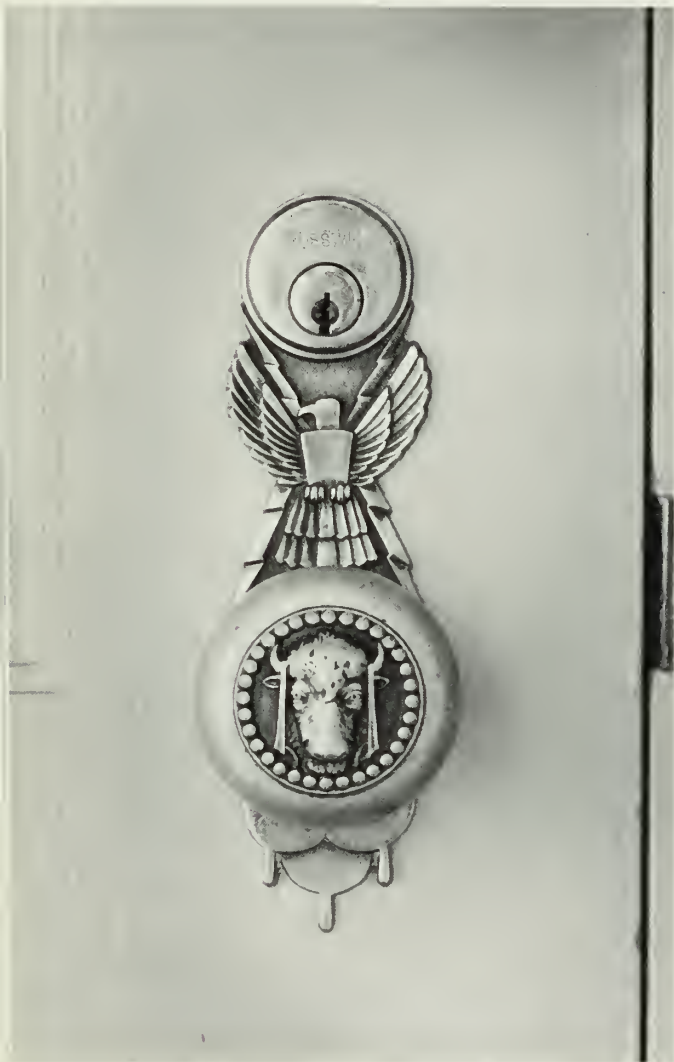
290

290. BRONZE DOOR PULLS. The double doors of Suites 5116, 6000, 6616, 6654, and of the Secretary's Conference Room (5160) have bronze door pulls on one side and push plates on the opposite side. Detail of Drawing No. 229. Document stored at the National Record Center, Suitland, Maryland, Record Group 121-76-301, Box 86, No. DC 0020 ZZ 205.

Full-scale details of the hardware were drawn (Figs. 287, 288, 290, and 292). Whether an independent studio made models of the hardware or whether each hardware manufacturer submitted its own interpretation has not been determined. (Photographs of hardware models have not been found.) Russwin Hardware Co. of New Britain, Connecticut, however, did supply most of the hardware for the building, including the buffalo doorknobs and ornamental pulls for double doors.

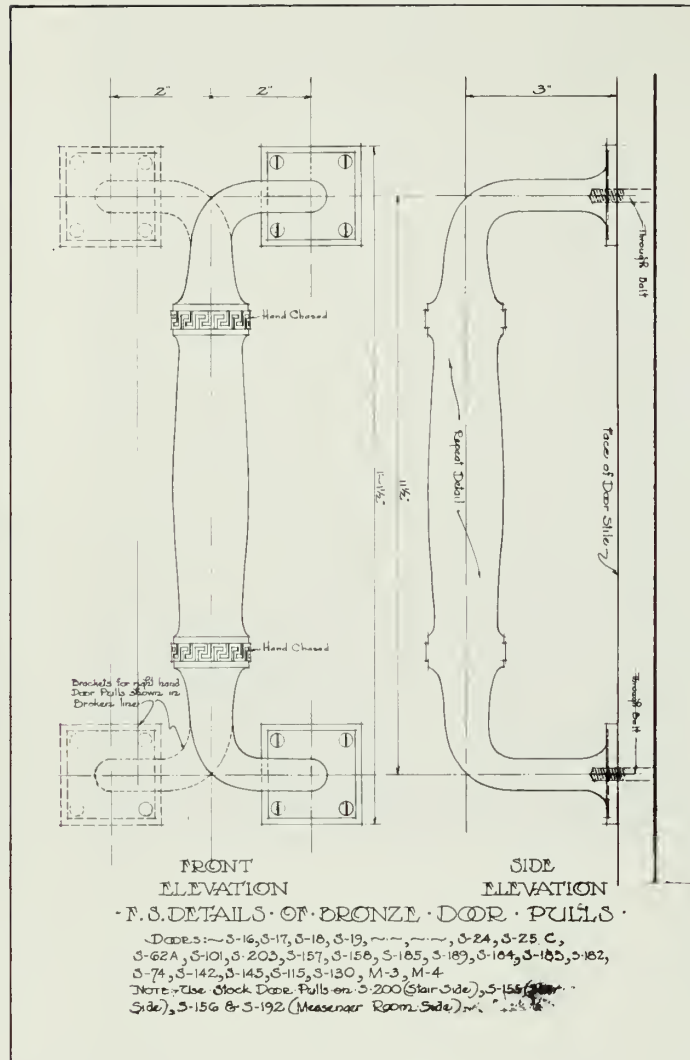
291. DOOR PULLS FOR EXECUTIVE OFFICES. The door pulls are simple, with a Greek fret band design at the top and bottom of the hand grip. The pulls have a smooth finish and the ornament is hand chiseled. The total vertical dimension is 1 foot 1½ inches. The push plates are also smooth with a double fillet border. Brooks Photographers, Bethesda, Maryland, 1976, HABS Collection.

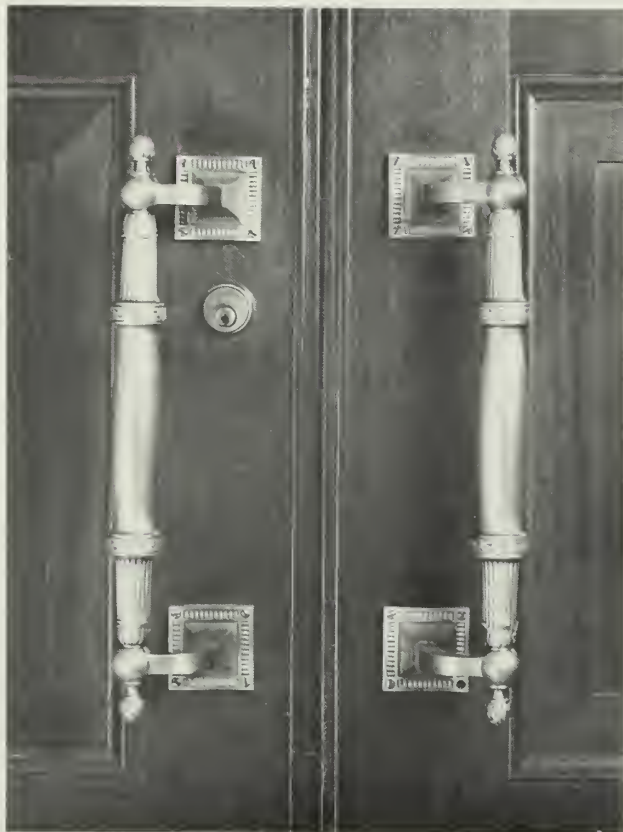
292. DOOR PULLS AND PUSH PLATES FOR THE AUDITORIUM (CONFERENCE HALL) AND LIBRARY. The door pulls and push plates for the double doors to the Auditorium and Library were designed to embellish both the doors and the South Lobby. Detail of Drawing No. 229. Document stored at the National Record Center, Suitland, Maryland, Record Group 121-76-301, Box 86, No. DC 0020 ZZ 205.

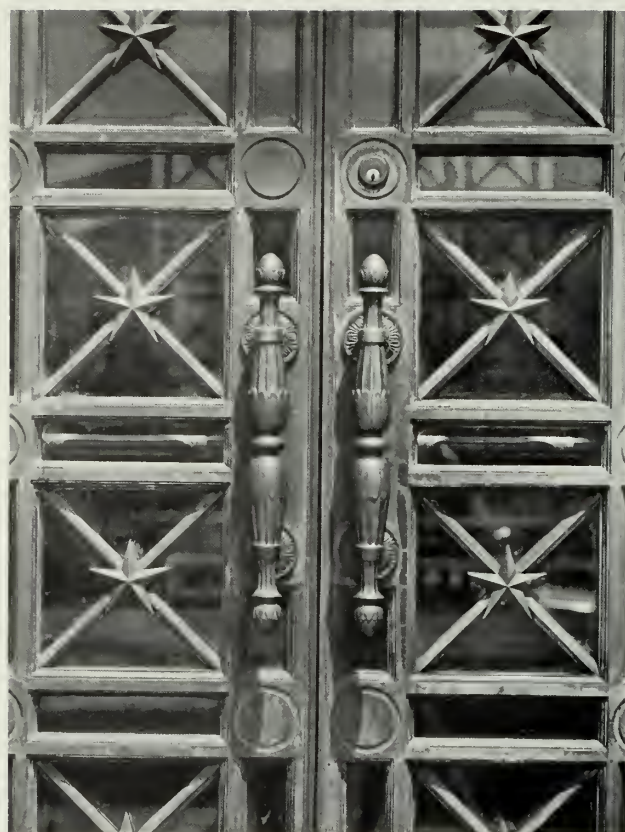
293

293. DOOR PULLS FOR AUDITORIUM (CONFERENCE HALL) AND LIBRARY. The door pulls and push plates for the double doors to the Auditorium and Library are very ornate. Similar to the door pulls in Fig. 291, the hand grips have a Greek fret border at both the top and bottom. Above and below these borders the handles have a tapered, reeded section capped with leaves, a ball and a pineapple ornament. The bent arm to the door has a square section and the plates on the door have reeded borders. The keyhole is on a round cylinder separate from the door pulls. The finish is polished phosphor bronze and the total vertical dimension is 1 foot 5 inches. Brooks Photographers, Bethesda, Maryland, 1976, HABS Collection.

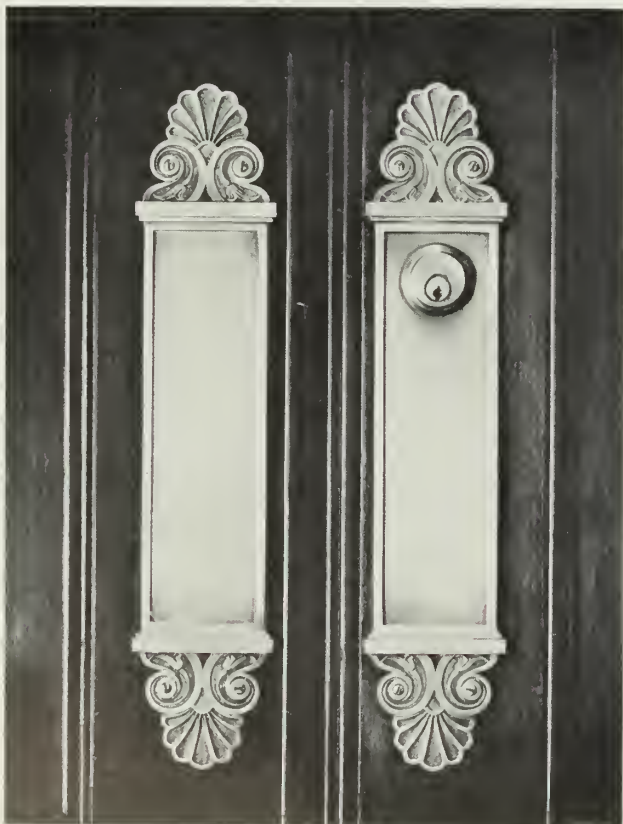
294

294. PUSH PLATES FOR AUDITORIUM (CONFERENCE HALL) AND LIBRARY. The push plates on the Auditorium and Library double doors consist of a rectangular plate with an anthemion design at the top and bottom. The plate has a fine matted surface with a smooth fillet border. The anthemions have both a fine matted and smooth finish to highlight the design. The round key cylinder is on the right push plate near the top. The total vertical dimension including the anthemions is 1 foot 5 inches. Brooks Photographers, Bethesda, Maryland, 1976, HABS Collection.

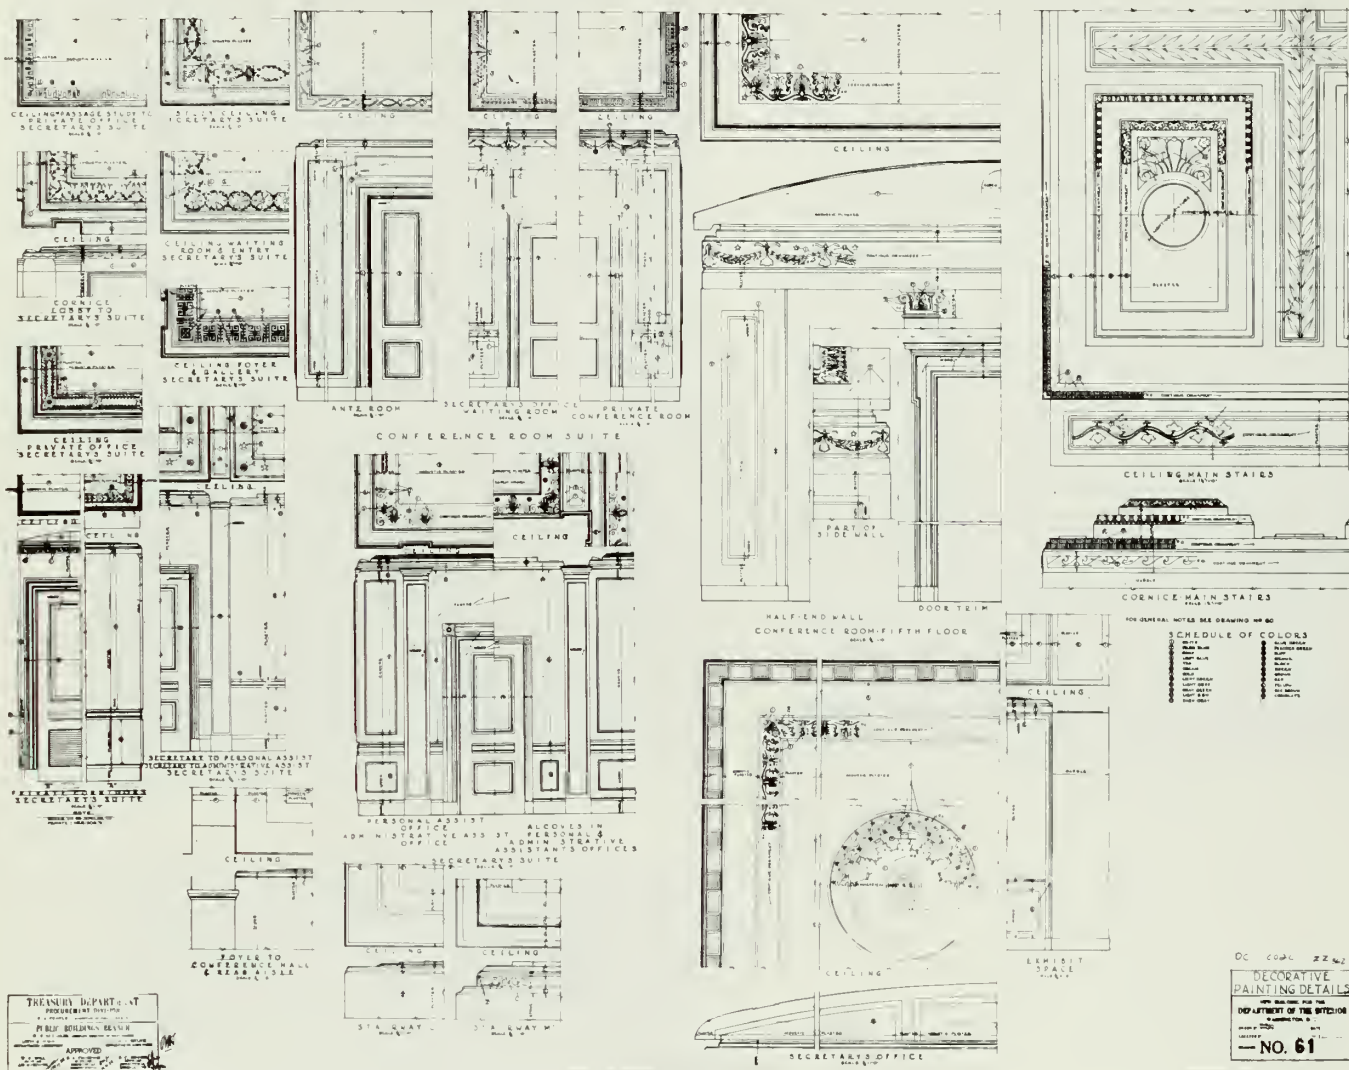
297. DECORATIVE PAINTING DETAILS. Drawing No. 61 shows a painting scheme for the Secretary's Suite (6000), the Secretary's Conference Room (5160), the Grand Stairs (Stairs G), Stairs L and M, and the Foyer to the Conference Hall (Auditorium). Drawing No. 61, by Buell Solon, Dec. 2, 1936. Document stored at the National Record Center, Suitland, Maryland, Record Group 121-76-301, Box 89, No. DC 0020 ZZ 362.

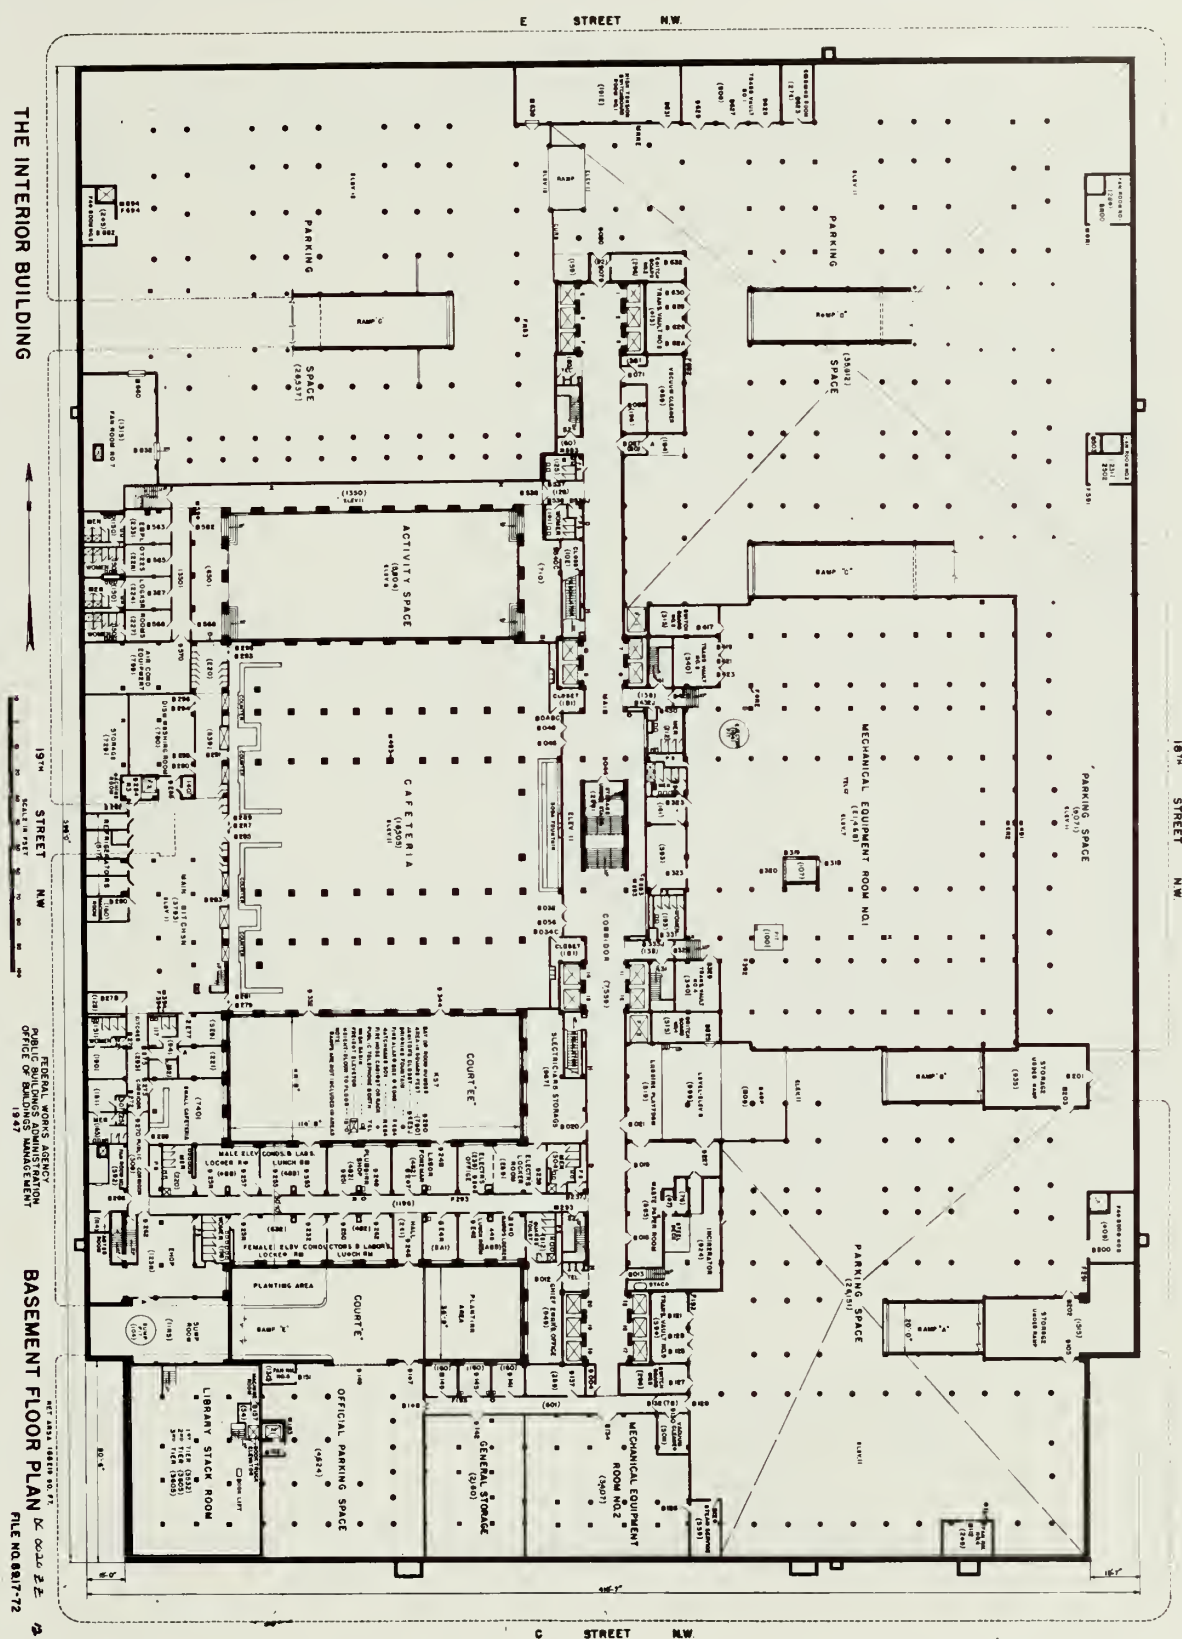
298. BASEMENT FLOOR PLAN. Revised by Federal Works Agency, 1947. Document stored at the National

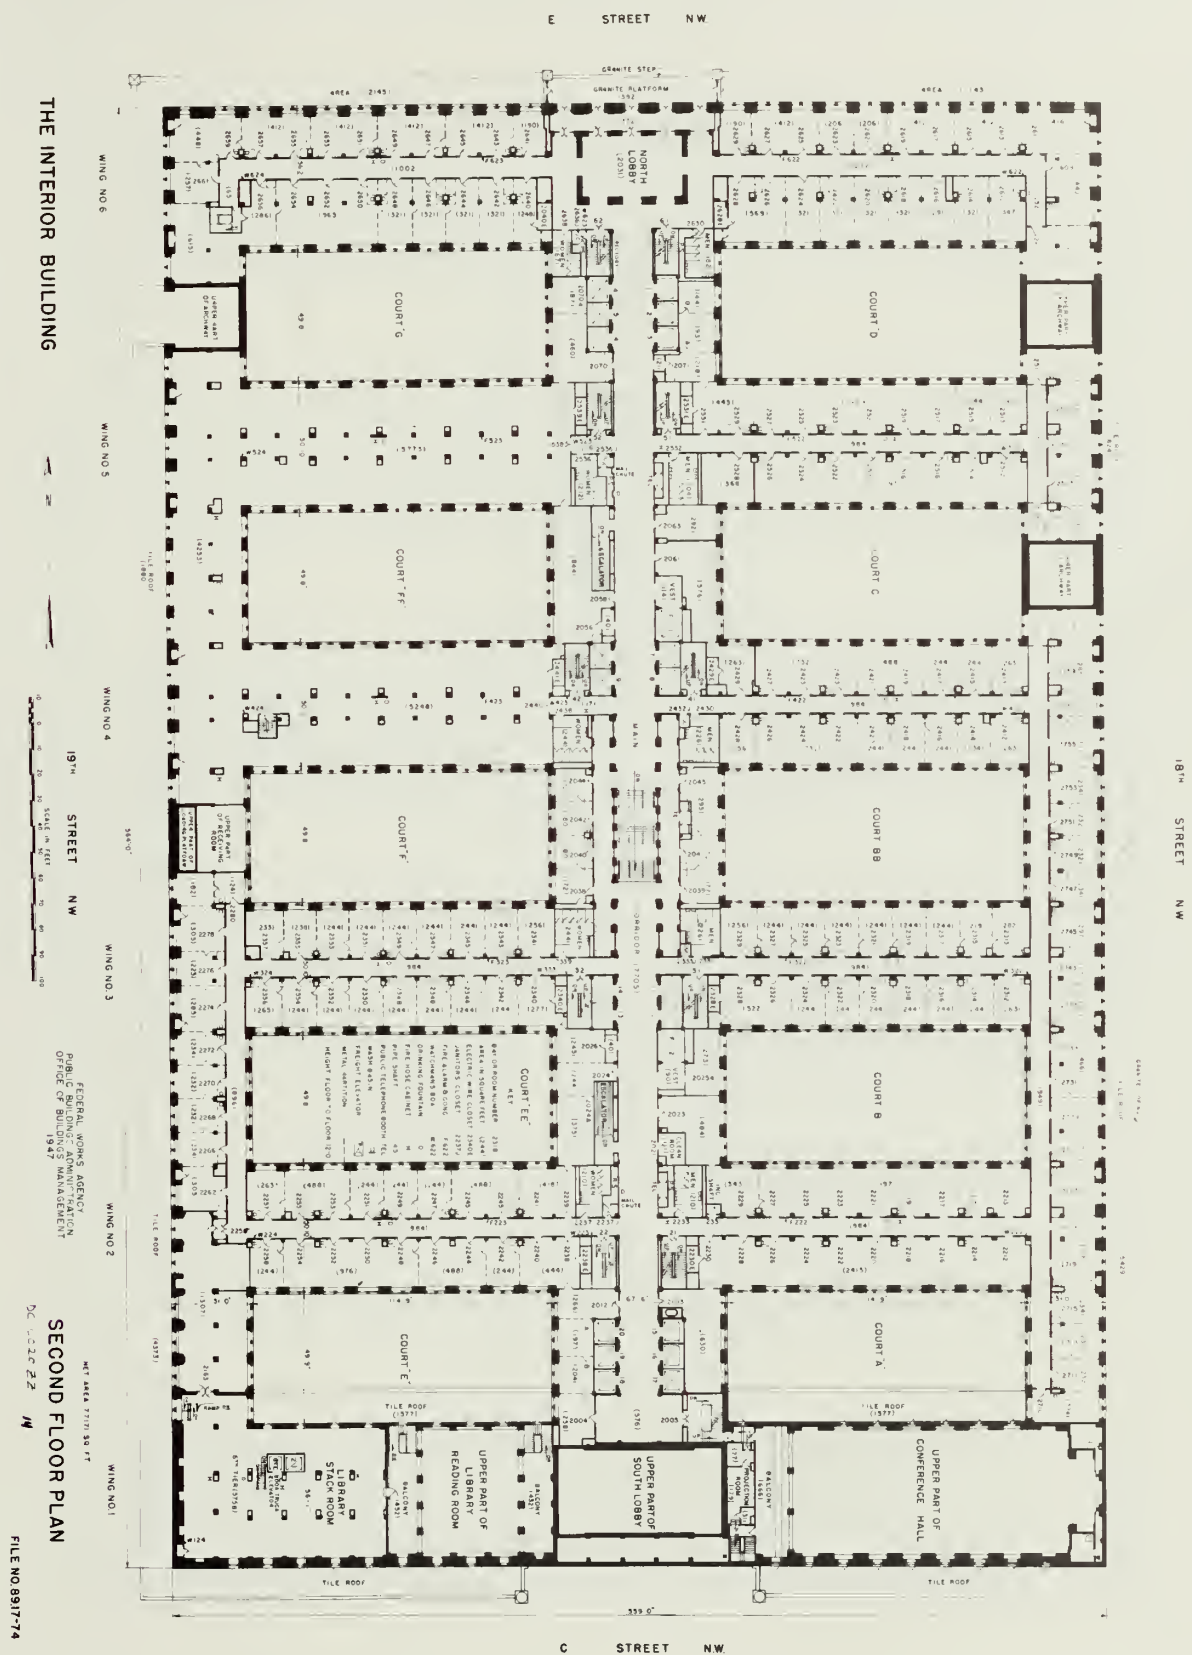
300. SECOND FLOOR PLAN. Revised by Federal Works Agency, 1947. Document stored at the National Record

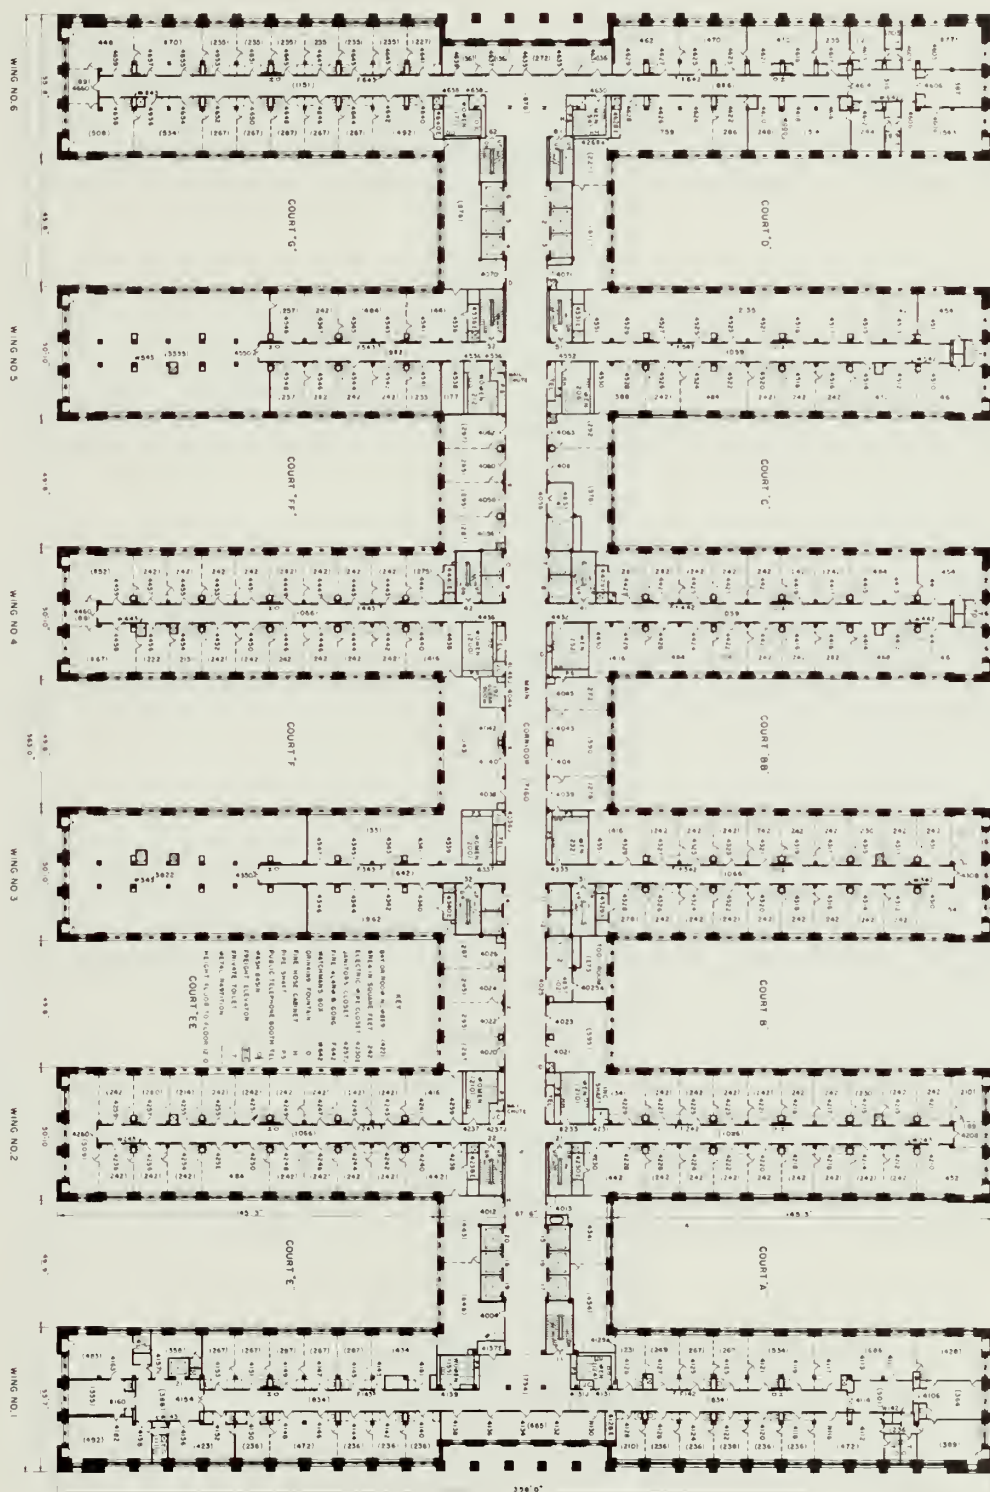
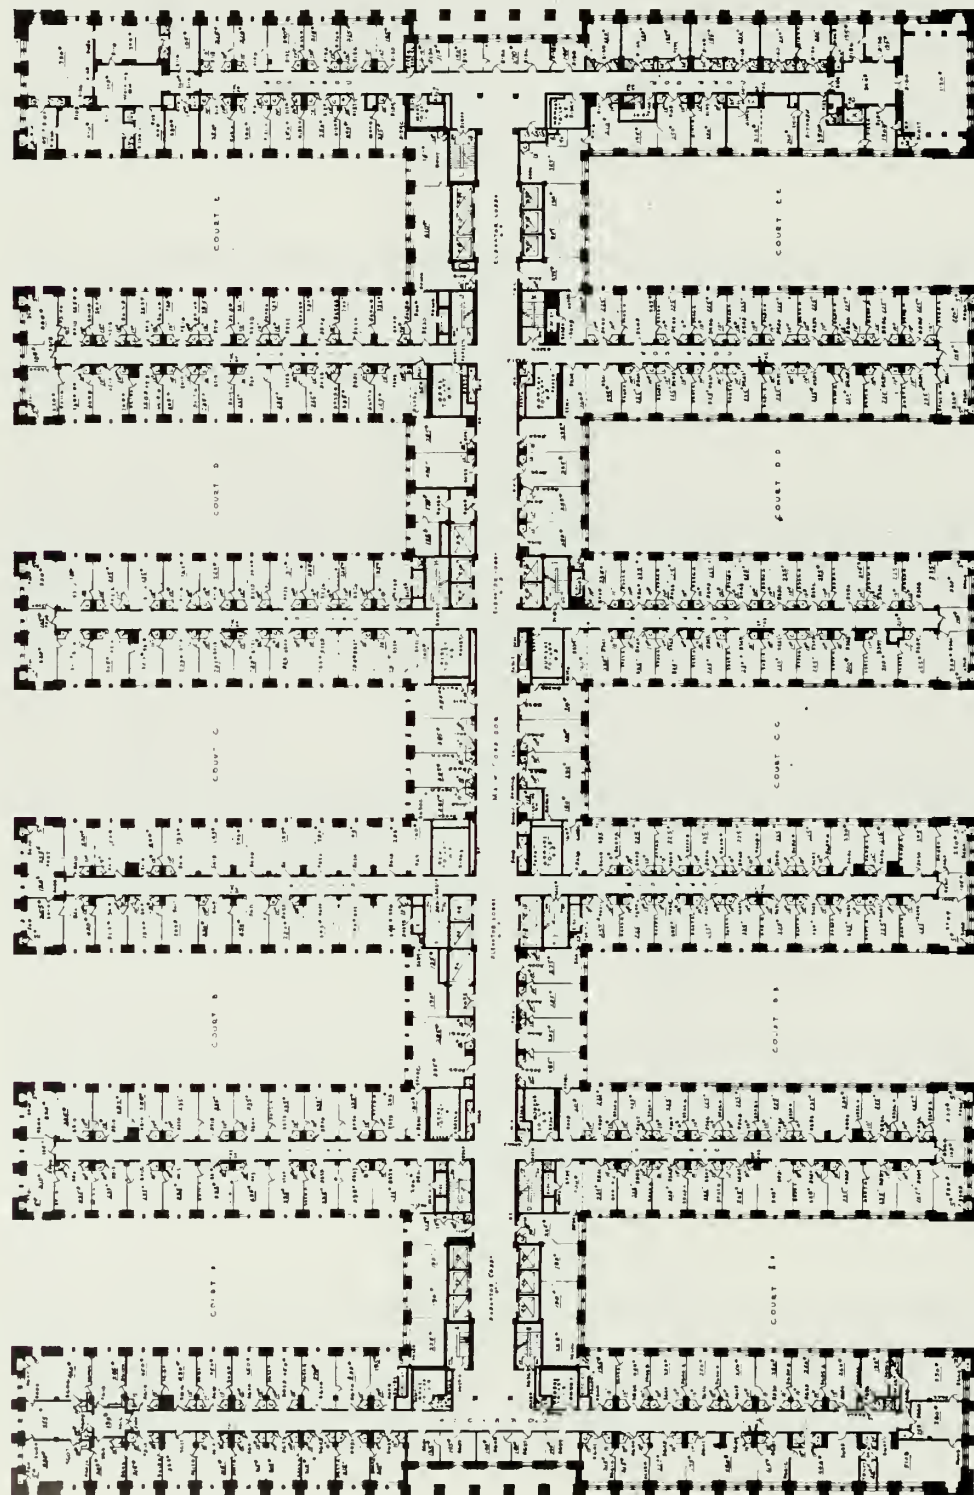
302. FOURTH FLOOR PLAN. Revised by Federal Works Agency, 1947. Document stored at the National

Record Center, Suitland, Maryland, Record Group 121-76-301, Box 83, No. DC 0020 ZZ 16.
